专题——飞机结构腐蚀修理与防腐改进技术研究

直升机旋翼桨叶有机涂层防护性能在户内加速 试验中的变化

Changes of Protective Properties of Organic Coatings on Helicopter Rotor Blade during Indoor Accelerated Testing

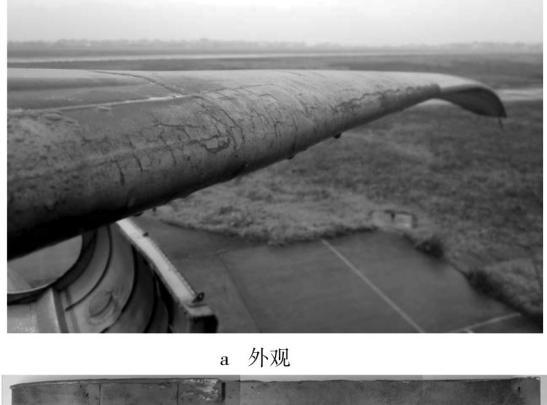
图1 旋翼桨叶

旋翼桨叶外观如图1所示,主要由铝合金大梁、钢 制梳形接头和后段件组成。大梁是旋翼主要受力件, 采用ABT-1铝合金压制加工成封闭空心整体件。梳 形接头通过MΠΦ-1胶和21个螺栓以及大梁形成一 体,大梁后缘装有21个带蜂窝结构的后段件。实验中 共使用2类试验件,其中,"新修桨叶试验件"采用未使 用的桨叶后段件,沿桨叶长度方向截取130 mm、宽度 方向截取140 mm(从叶尖开始)的试验段,并按实际修 理工艺进行喷漆;"报废桨叶试验件"采用经过多年服 役已经报废的旋翼桨叶,沿桨叶长度方向截取140 mm 长的试验段。

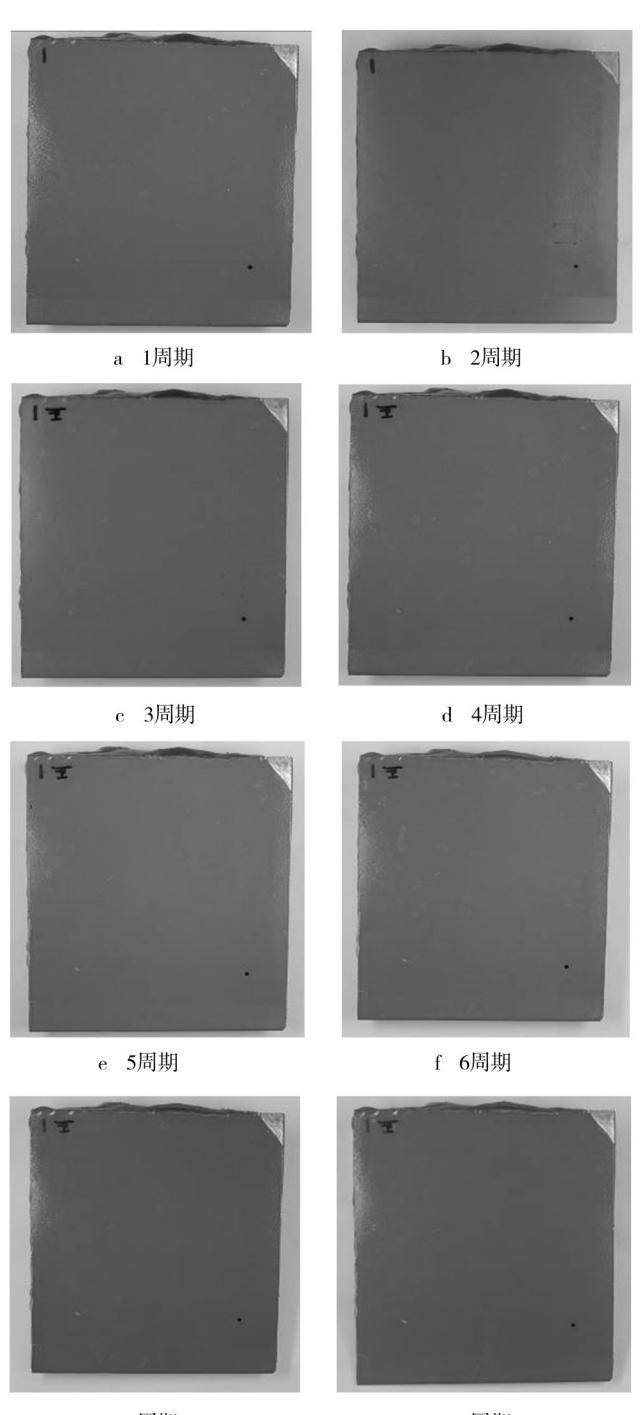
图2 新修桨叶试验件表面在1~8个周期加速试验后的照片

新修桨叶试验件在经历1~8个周期户内加速试验 后上表面(即受到紫外辐照的一侧)的照片如图2所 示。可以发现,试验件的有机涂层表面形貌在8个户 内加速试验周期后并未发生明显变化,也不存在粉 化、开裂、起泡、剥落或者泛金的现象。新修桨叶试验 件表面在8个周期加速试验后的扫描电镜照片如图3 所示,与后文中讨论的报废桨叶试验件表面防护涂层 相比,新修桨叶试验件氧化膜厚度较小,另外存在底 漆涂层厚度不均匀的现象,但经过8个周期户内加速 试验后尚未出现空洞或裂纹。

1) 经历1~8个周期模拟高原环境户内加速试验后, 新修桨叶试验件有机涂层表面形貌未发生明显变化。

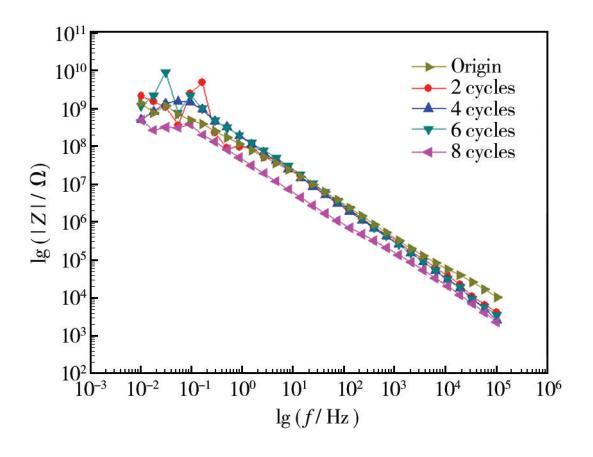
图4 新修桨叶试验件表面的电化学阻抗谱Bode图 Fig.4 EIS Bode diagram of the top surface of the repaired blade

新修桨叶试验件表面在经历1~8个周期户内加速 试验后的电化学阻抗谱Bode 图如图4所示,原始和2, 4,6,8周期后的特定频率电化学阻抗模值IZI_{F01Ha}分别 为4.9×10⁸,2.6×10⁹,1.5×10⁹,2.3×10⁹,3.9×10⁸Ω。 由图4可见,在6个户内加速试验周期后,试验件的电 化学阻抗模值未发生显著下降,各户内加速试验周期 后的模值曲线与未经历户内加速试验情况下的模值 曲线基本重合。这与试验件有机涂层表面形貌在户 内加速试验过程中未发生明显变化的结果一致。经

历8个周期的户内加速试验后,试验件表面有机涂层 Bode曲线呈现小幅下降,说明有机涂层经历加速试验 后防护性能下降,有机涂层内部实际上已经产生了微 小损伤,成为外界溶液可以渗透的通道。事实上,在 受到紫外线的作用时,有机涂层的树脂高分子链发生 光引发链增长、链终结等系列反应,最后分子链发生 断裂,生成亲水性基团。之后,有机涂层中分子链的

降解产物如小分子醇、醚等挥发,亲水性氧化产物(如 羧酸)溶解于水中,离开有机涂层。因此,随着老化降 解,有机涂层内部孔隙率逐渐增加,有机涂层防护性 能逐渐退化。

2)前6个周期户内加速试验后,新修桨叶试验件 的电化学阻抗模值未发生显著下降;经历8个周期的 户内加速试验后,试验件表面有机涂层Bode曲线呈现 小幅下降,表明有机涂层防护性能下降。

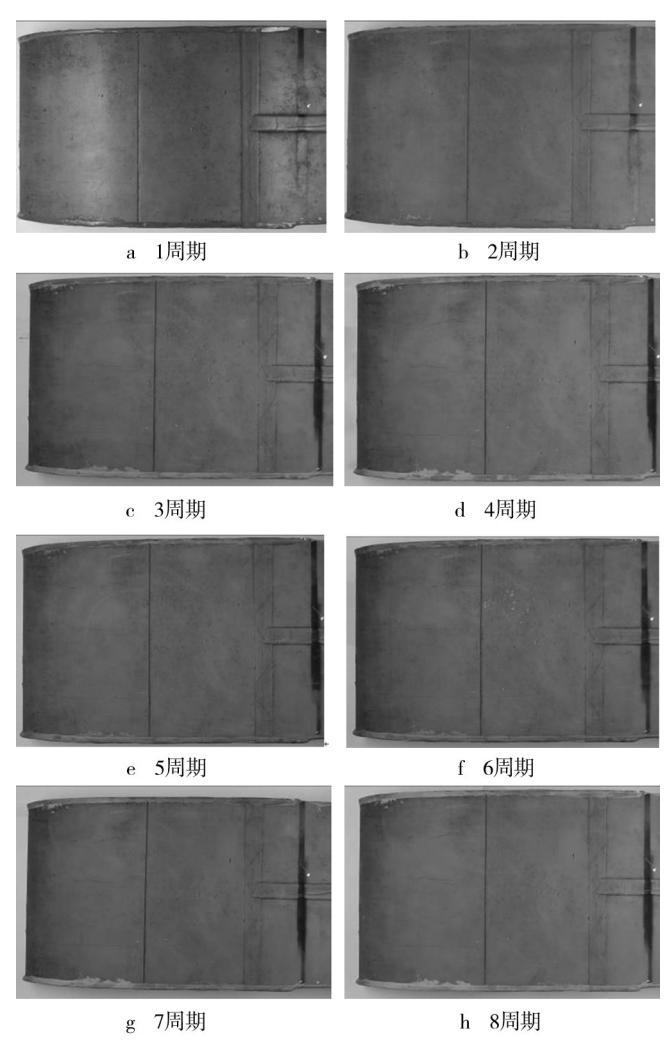
图5 报废桨叶试验件前段部分表面在1~8个周期加速试验后 的照片

报废桨叶试验件表面在1~8周期加速试验后的照 片如图5--7所示。随着加速试验的进行,试验件表面 的有机涂层逐渐失去光泽;经过6个周期的加速试验 后,开始出现轻微的粉化现象;经过8个周期的户内加 速试验后,尚未出现有机涂层起泡、剥落或者泛金的 现象。

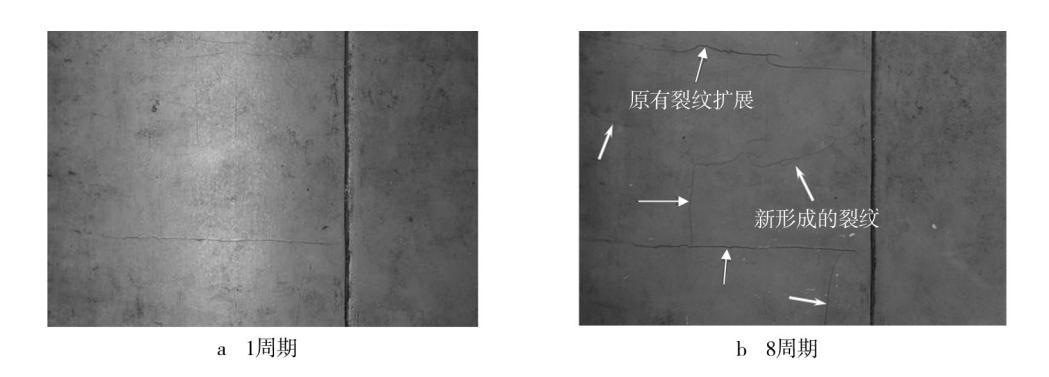
图 8 报废桨叶试验件前段部分表面局部区域在1周期和8周期后的照片 Fig.8 Photos of the top surface of the front end of discarded blade specimen after 1 and 8 cycles of accelerated testing

报废桨叶试验件前段部分表面同一局部区域在1 周期和8周期后的照片对比如图8所示。可见在加速 试验过程中,报废桨叶试验件的前段部分表面原有的 裂纹加深,如图8中细箭头所指示,同时出现更多新形 成的裂纹,如8图中加粗箭头所指示。这些更加细小的 裂纹由原有裂纹发展出来,而且这种裂纹有扩展连接 成网络的趋势。有机涂层表面裂纹长短不一,总体上 沿垂直或平行于桨叶长度分布方向,但是发展走向不 断发生微小变化。某课题组前期研究表明,外加拉应 变导致有机涂层防护性能下降,原因是拉应变超过涂

层材料断裂强度,从而形成显微裂纹^[7-8]。报废桨叶试 验件在加速试验过程中虽然未受到外加拉应变,但前 段部分曲率变化大,表面涂层在施工固化过程中会产 生收缩内应力,表面在同时受到收缩内应力和紫外辐 照等环境因素的作用时产生裂纹,构成外界溶液进入 内部的通道。有机涂层的吸水率与空洞、裂纹等缺陷 的数量成正比,Cl⁻,O₂和H₂O通过孔隙进入涂层中,并 到达有机涂层/合金界面。

3) 报废桨叶试验件表面有机涂层随加速试验的进行逐渐失去光泽,经过6个周期后开始出现粉化现象,前段部分表面原有的裂纹加深,同时出现更多新形成的裂纹且有扩展连接成网络的趋势,后段件之间连接处的密封材料开裂现象更加严重。

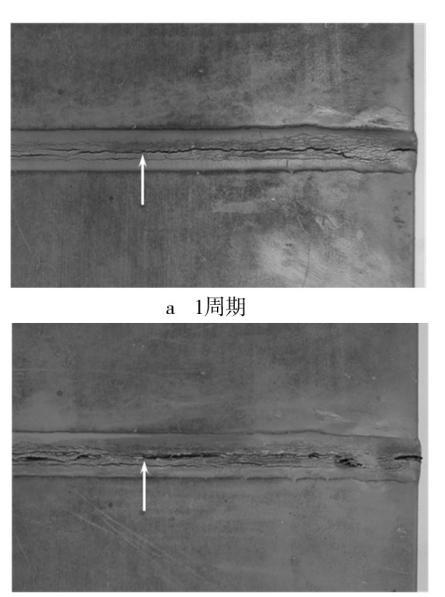
- 图 9 报废桨叶试验件后段部分表面局部区域在1周期和8周 期后照片
- Fig.9 Photos of the top surface of the back end of discarded blade specimen after 1 and 8 cycles of accelerated testing

对比报废桨叶试验件后段部分表面在1周期和8 周期后的照片(如图9所示),后段件之间连接处的密封 材料开裂现象较未进行户内加速试验时的情况更加严 重,微裂纹和空洞非常明显。报废桨叶试验件表面3个 区域未经历户内加速试验时的电化学阻抗谱Bode图如 图10所示,报废桨叶试验件表面3个区域在经历8个周 期户内加速试验后的电化学阻抗谱 Bode 图如图 11 所 示,特定频率电化学阻抗模值|Zlf0.11+在表2中列出。可 以发现,报废桨叶试验件表面3个区域的模值曲线基本 重合,说明不同区域有机涂层的防护性能较为均匀。 在8个周期的户内加速试验后,报废桨叶试验件表面有 机涂层的电化学阻抗模值未发生显著下降,特定频率 电化学阻抗模值与原始情况相比,仅由5.4×10°Ω下 降到了 $3.1 \times 10^{\circ} \Omega$, $|Z|_{F0.1 Hz}$ 只下降了不到 1 个数量级, 这与试验件非密封结合部位的表面形貌在户内加速试 验过程中未发生明显变化的结果一致。报废桨叶试验 件后段部分表面的SEM图片如图12所示,其中横截面 的照片显示表面氧化膜、底漆涂层和面漆涂层厚度均 匀、完整,尚未出现空洞或裂纹。

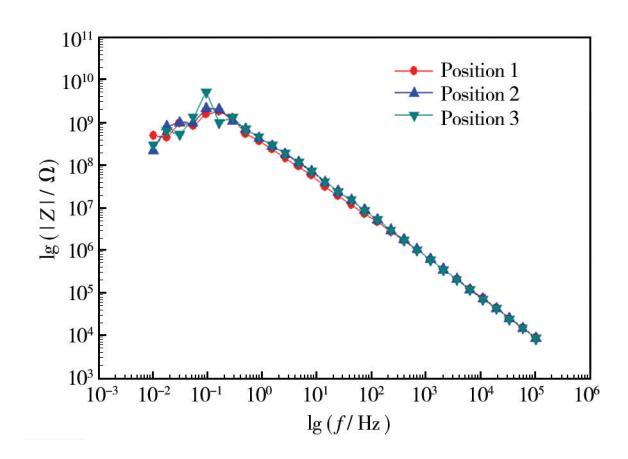
- 图 11 报废桨叶试验件后段部分表面 8 周期后的电化学阻抗谱 Bode 图
- Fig.11 EIS Bode diagram of the top surface of the back end of discarded blade specimen after 8 cycles of accelerated testing

发现,未经历户内加速试验的新修桨叶试验件的电化 学阻抗模值曲线小幅低于经历了8个周期户内加速试 验的报废桨叶试验件,说明桨叶后段件部位实际修理 工艺所采用的国产有机涂层防护性能与原始有机涂 层相比存在一定差距。

4) 在8个周期户内加速试验后,报废桨叶试验件 表面有机涂层的电化学阻抗模值未发生显著下降,特 定频率电化学阻抗模值IZI_{F0.1H2}与原始情况相比仅下降 了不到1个数量级,且模值曲线仍然小幅高于未经历 户内加速试验的新修桨叶试验件的模值曲线。
