重大工程装备

AIN 覆铜板盐雾环境下的退化行为研究

Degradation Behavior of Copper Metallized Aluminum Nitride in Salt Spray Environment

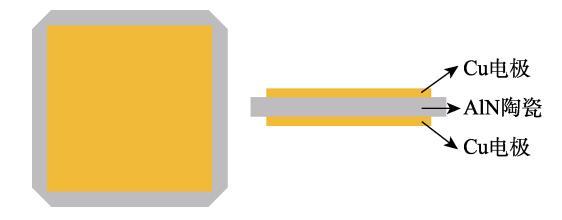
试验用 AIN 覆铜板如图 1 所示,试样尺寸为 20 mm×20 mm×1.25 mm,其中,AIN 陶瓷厚度约为 0.6 mm,表面 Cu 电极厚度约为 0.3 mm,Cu 电极采 用钎焊工艺与陶瓷基体进行连接。同时,铜电极表面 先后沉积有 Ni-P 镀层和 Au 镀层。

图 1 AIN 覆铜板结构 Fig.1 Structure diagram of copper metallized AIN

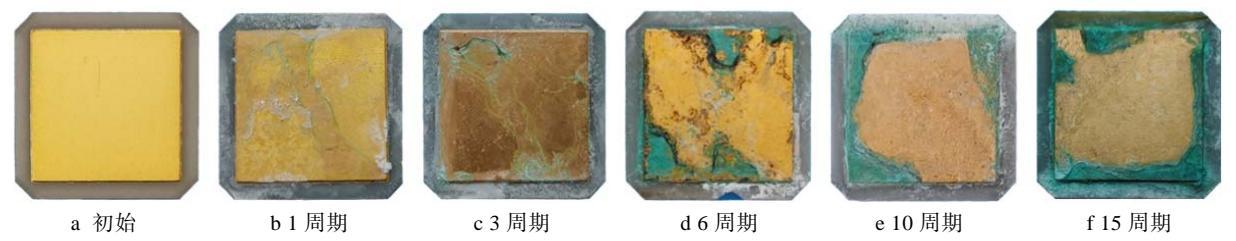
不同盐雾周期 AIN 覆铜板的宏观形貌变化如图 2 所示。原始样品 Cu 电极表面光亮、平整、无瑕疵; 盐雾试验 1 周期后, AIN 覆铜板表面生成少量绿锈; 试验 3 周期后,电极表面绿锈区域面积增加,整体颜 色变暗;试验 6 周期后,电极层边缘区域表面出现小 面积的锈斑;试验 10 周期,电极层表面锈斑大面积 扩张,呈现青蓝色;试验 15 周期,电极层表面绿锈 区域明显增加,呈现深绿色。Cu 电极表面的腐蚀程 度随盐雾试验时间延长明显加剧,这可能是在中性盐 雾试验下 Cu 电极发生腐蚀生成"铜绿"。

图 2 不同盐雾周期 AIN 覆铜板的宏观形貌变化

Fig.2 Macroscopic morphology change of copper metallized AlN under different salt spray cycles: a) initial; b) 1 cycle; c) 3 cycle; d) 6 cycle; e) 10 cycle; f) 15 cycle

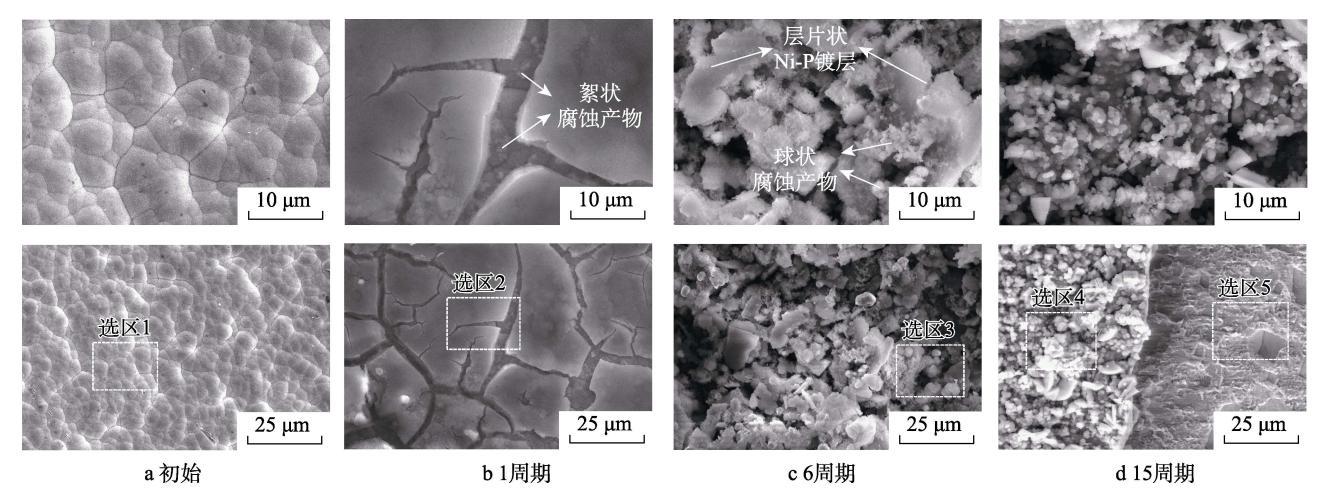
不同盐雾周期下 AIN 覆铜板表面 Cu 电极的微观 形貌如图 3 所示。初始试样 Cu 电极表面 Ni-P 镀层呈 现胞状组织结构, 胞粒之间排布紧密, 未观察到气孔、 裂纹等缺陷^[9-10];盐雾试验 1 周期后,在 Cu 电极表 面部分区域观察到"开裂"现象, 且裂缝处能观察到 少量絮状物质;试验6周期后,在电极表面观察到部 分层片状物质和球状腐蚀产物;试验15周期后,电 极表面被大量细小球状腐蚀产物覆盖,形成一定厚度 的腐蚀层,同时部分区域腐蚀产物会完全剥落,露出 粗糙的Cu基体表面。这表明随着盐雾试验周期延长, Cu电极基体表面Ni-P镀层开始出现裂缝,导致Cu 电极基体与腐蚀介质接触,生成腐蚀产物(见图3b)。 随后Cu电极基体持续发生腐蚀,大量疏松多孔状腐 蚀产物向外生长,使表面Ni-P镀层进一步开裂、破 碎,呈现层片状形态(见图3c)。最终,Cu电极表面 形成大面积的腐蚀区域,腐蚀产物"铜绿"呈现细小 球状形态,其主要组成成分可能为Cu的氧化物和氯 化物。

图 3 不同盐雾周期下 AIN 覆铜板表面 Cu 电极 SEM 图谱

Fig.3 SEM of Cu electrode on the surface of copper metallized AlN under different salt spray cycles: a) initial; b) 1 cycle; c) 6 cycle; d) 15 cycle

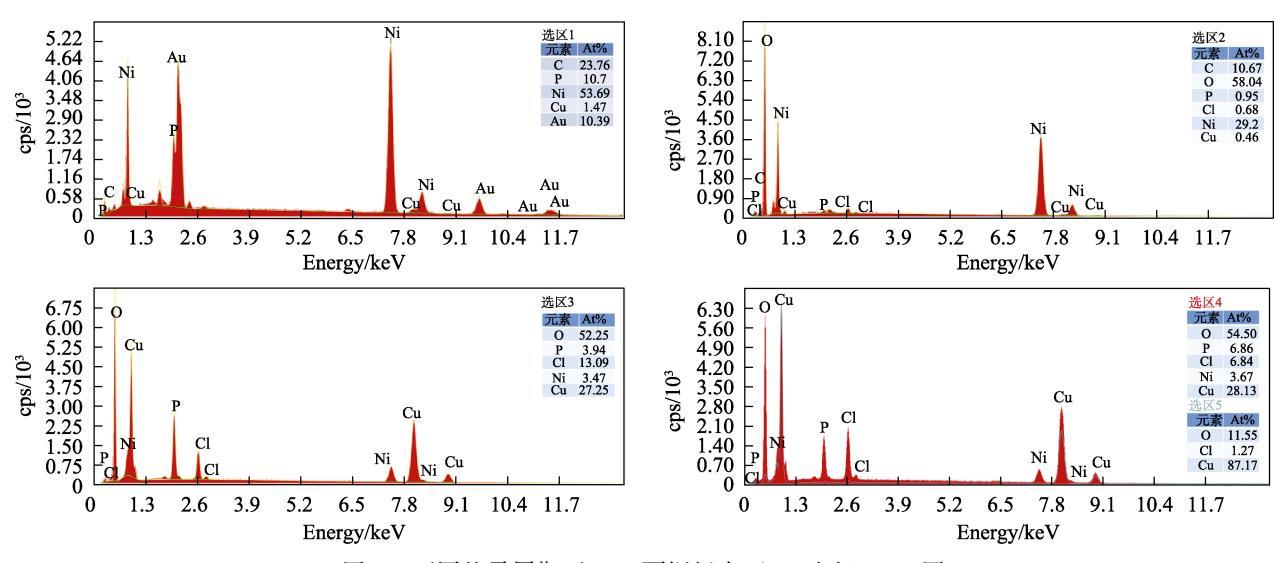
通过 EDX 测试进一步分析盐雾试验过程中 Cu 电极表面元素含量的变化,如图 4 所示。初始时,试 样电极表面主要元素为 Ni、P 和 Au,EDS 信号来源 于 Cu 电极表面质量良好的 Ni-P 镀层及 Au 镀层;盐 雾试验 1 周期后,扫描区域 O 元素含量急剧增加, 这可能是由于表面 Ni-P 镀层裂纹等缺陷处腐蚀介质 渗透,导致 Cu 电极基体发生腐蚀,同时也吸附了环 境中大量 O 元素;盐雾试验 6 周期后,检测出高含 量的 Cu、O 和 Cl 元素,这可能是由于 Cu 电极腐蚀 产生的 Cu₂O、Cu₂(OH)₃Cl 等腐蚀产物向外生长导致, 与任海滔等的报道一致^[11],而 Ni 和 P 元素含量降

图 4 不同盐雾周期下 AIN 覆铜板表面 Cu 电极 EDX 图 Fig.4 EDX of Cu electrode on the surface of copper metallized AlN under different salt spray cycles

低,可能是由于 Cu 基体产生的腐蚀产物会导致 Ni-P 镀层部分失效剥落; 盐雾试验 15 周期后, 电极表面 部分区域生成的腐蚀介质会完全剥落,露出 Cu 电极 基体。

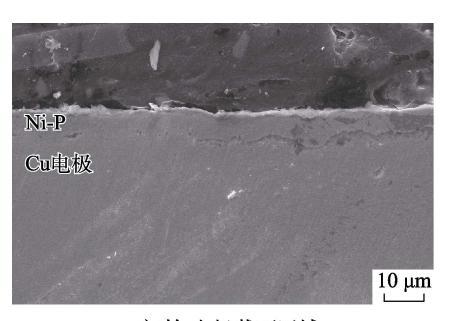
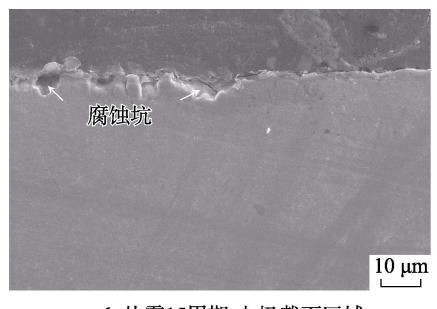
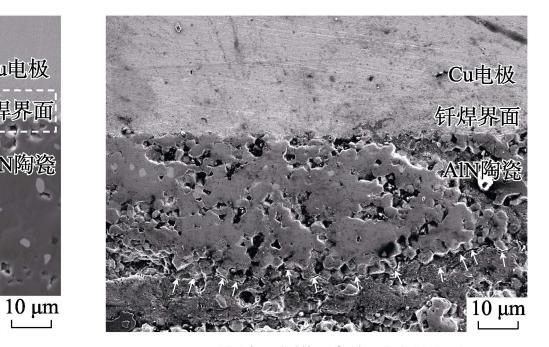
不同盐雾周期下 AIN 覆铜板截面的微观形貌如 图 5 所示。初始和盐雾试验 15 周期后, Ni-P 镀层与 Cu电极均结合紧密,而盐雾试验15周期试样电极表 面部分区域观察到腐蚀坑,这是由于 Cl⁻等腐蚀介质 导致 Cu 电极局部区域发生腐蚀(见图 5a、b)。陶瓷/ 金属钎焊界面区域,盐雾试验前后都保持着良好的界 面结合状态,无分层、开裂等退化现象,这说明钎料

a初始-电极截面区域

层与金属、陶瓷层界面润湿效果良好,且具有良好的 化学稳定性[12-13],试验周期内钎焊界面的微观状态无 明显退化。盐雾试验 15 周期后,在 AIN 陶瓷截面区 域,观察到少部分沿着 AIN 晶粒延伸扩展的细小裂 纹,说明 AIN 陶瓷基体内部微观结构发生了一定程 度的退化。这可能是由于长时盐雾试验过程中,H₂O 会沿着宏观孔隙、晶界等缺陷扩散进入陶瓷内部,在 局部区域造成 AIN 陶瓷水解,逐渐形成微裂纹(见 图 5c、d)^[14-15]。

b 盐雾15周期-电极截面区域

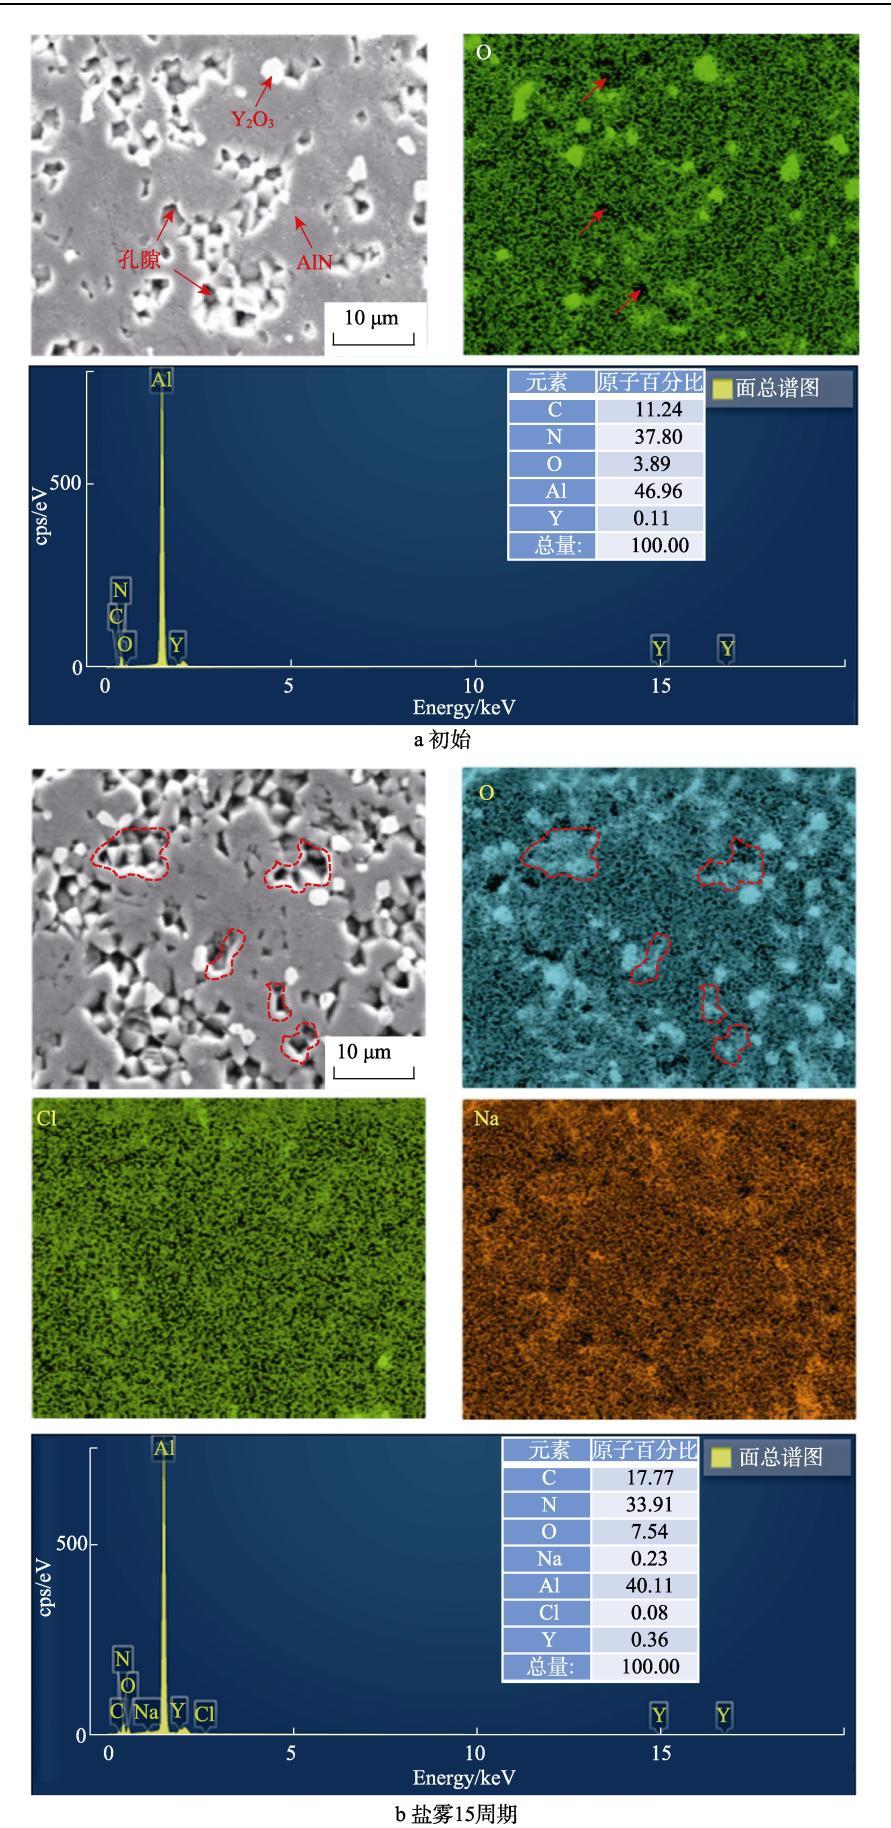
进一步对 AIN 陶瓷基体截面进行能谱分析,如 图 6 所示。初始试样中, O 元素的原子分数为 3.89%,

图 6 盐雾试验前后 AlN 陶瓷截面 EDS 图谱 Fig.6 Section EDS of AlN ceramics before and after salt spray experiment: a) initial; b) 15 cycles

且 mapping 图显示 O 元素分布边界清晰,信号主要 来源于 AlN 陶瓷烧结助剂(图 6a 中 Y₂O₃),而陶瓷 孔隙及其周围 O 元素信号弱。盐雾试验 15 周期后, 能谱分析显示,O 元素的原子分数增加为 7.54%,同 时检测到了 Cl 和 Na 元素,其原子分数分别为 0.08% 和 0.23%。mapping 图显示,O 元素呈现一定弥散状 态分布,除了存在于 AlN 陶瓷烧结助剂处,在一些 孔隙及孔隙边缘处都检测出明显的 O 元素信号。这 可能是由于在盐雾试验过程中,H₂O、Na⁺、Cl⁻等逐 渐扩散进入陶瓷基体内,并在孔隙等缺陷处富集,而 导电粒子在陶瓷内部富集会一定程度恶化 AlN 陶瓷 的电绝缘特性^[16]。

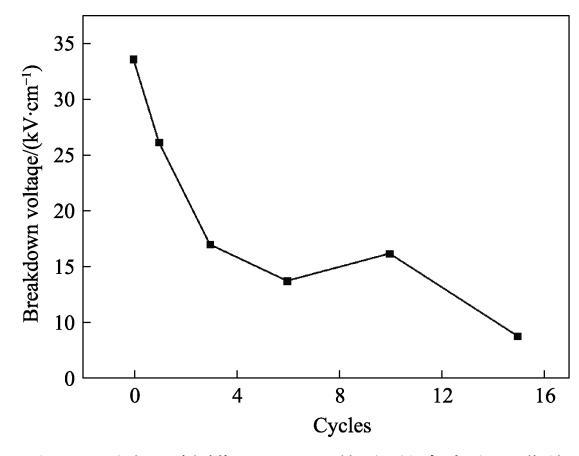
不同盐雾周期下 AIN 覆铜板击穿电压曲线如图 7 所示。AIN 覆铜板击穿电压参数随盐雾试验周期呈现 明显的下降规律,初始试样具有良好的电绝缘特性, 击穿电压为 33.62 kV/cm。第 15 周期时,试样击穿电 压下降为 8.80 kV/cm,击穿电压最大退化率为 73.8%。 陶瓷材料电绝缘特性很大程度与其内部结构相关,陶 瓷内部孔隙率较高或者存在微裂纹都将使得漏电流 增大,导致陶瓷击穿电压下降^[17-18]。同时,长期盐雾 环境作用下,CI⁻和 Na⁺迁移扩散进入 AIN 陶瓷内部, 在局部区域发生聚集,增加局部区域的电导性能,形 成放电通道,最终导致 AIN 陶瓷更易被击穿,综合 导致其击穿电压显著下降。

图 7 不同盐雾周期下 AIN 覆铜板的击穿电压曲线 Fig. 7 Breakdown voltage of copper metallized AlN under different salt spray cycles

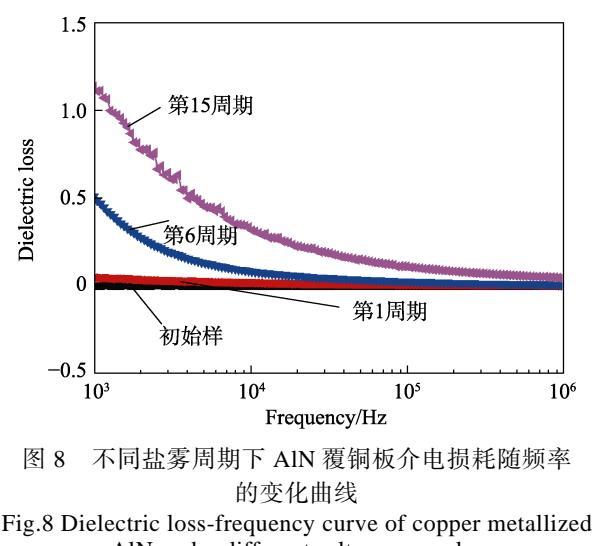
不同盐雾周期下 AIN 覆铜板介电损耗随频率变 化曲线如图 8 所示。随着盐雾试验周期的延长, AIN 覆铜板的介电损耗明显增加,且在低频区域介电损耗 的退化更加明显。盐雾 15 周期后, AIN 覆铜板的最 大介电损耗达 1.3 左右。陶瓷材料中杂质元素、孔隙、 微裂纹、晶间相等因素会显著影响其介电性能,尤其 是增加介电损耗^[19]。通过 AIN 陶瓷截面能谱分析可 知,盐雾试验过程中,环境中的 H₂O、Cl⁻、Na⁺会扩 散进入陶瓷内部。H₂O 会导致部分区域的 AIN 晶粒 表面发生水解^[20],而逐渐形成裂纹等缺陷; Cl⁻、Na⁺ 等在陶瓷内部缺陷处富集,会显著增加 AIN 覆铜板 的电导损耗,综合导致介电损耗明显加剧^[21]。

AlN under different salt spray cycles

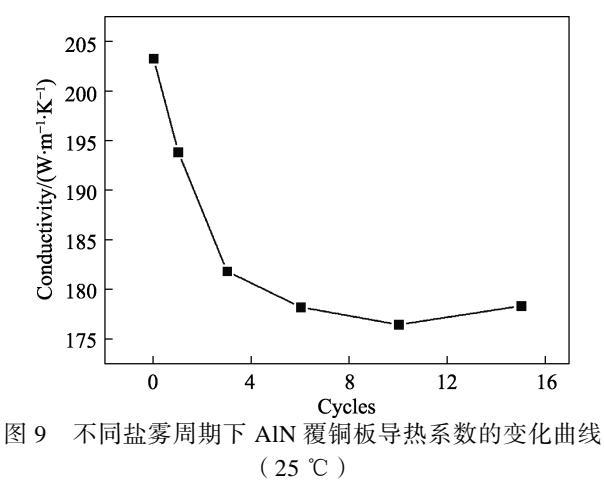
不同盐雾周期下 AIN 覆铜板导热系数(25℃)的 变化曲线如图 9 所示。初始 AIN 覆铜板展示出良好的 热学性能,导热系数为 203.36 W/(m·K)。盐雾试验 15 周期后,下降为 178.37 W/(m·K)。在盐雾试验 10 周期 时,导热系数退化率最大为 13.2%。整体来看,AIN 覆 铜板导热系数退化明显,下降速率呈现出先快再慢的规 律,最大退化幅度时已接近失效值(按相关标准规定, AIN 陶瓷板室温导热系数应在 170~220 W·m⁻¹·K⁻¹)。

Fig. 9 Thermal conductivity curve of copper metallized AlN under different salt spray cycles (25 ℃)

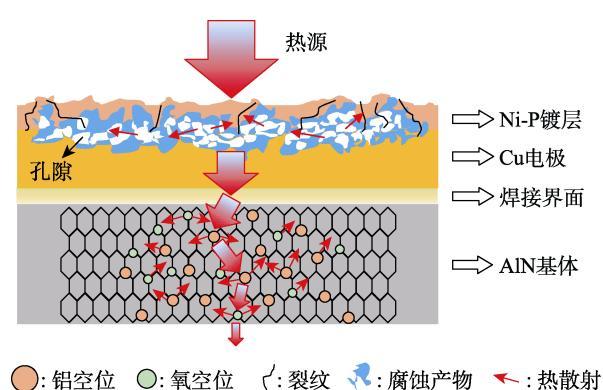
盐雾试验过程中,钎焊界面未观察到明显腐蚀、 开裂等微观结构退化现象,同时由于钎料主要成分为 Ti、Ag等化学性质稳定元素,环境适应性强,因此 其对 AlN 覆铜板导热系数退化影响较小。AlN 覆铜板 导热系数退化则主要源于 Cu 电极表面腐蚀和 AlN 陶 瓷基体微观结构退化 2 部分,其导热系数退化机理如 图 10 所示。

图 10 AlN 覆铜板盐雾试验后导热系数退化机理 Fig.10 Thermal conductivity coefficient degradation mechanism of copper metallized AlN after salt spray experiment

Cu 电极层表面腐蚀后形成疏松的腐蚀产物层, 覆盖于电极表面。由于腐蚀产物以金属氯化物和氧化 物为主,热量传输以声子传热为主导,又因腐蚀产物 层为多孔疏松结构^[22],因此热量由环境向 Cu 电极内 传导过程中存在一定的声子-缺陷散射现象。同时, 腐蚀产物层与 Cu 基体界面处则是通过声子与自由电 子热交换进行热量传导,降低了整体热量传递效率。 综合来看,腐蚀产物层增加了 Cu 电极热阻,进而导 致 Cu 电极导热系数下降。

文献[20,23]表明,在高湿度环境下,AIN 陶瓷表 面会发生缓慢的水解过程,生成非晶态的 AlOOH、 Al(OH)₃等物质,水解产物分解则会形成 Al₂O₃ 膜层 等,Al₂O₃ 膜层扩散溶入 AIN 陶瓷晶格中会形成一定 浓度的 Al 空位。在盐雾试验过程中,由于环境中H₂O、 Cl⁻、Na⁺扩散进入 AIN 陶瓷基体内部,一方面,H₂O 会引起部分 AIN 晶粒水解,通过分解、扩散形成一 定浓度的 O 缺陷和 Al 空位缺陷,AIN 陶瓷内空位缺 陷浓度增加,同时裂纹缺陷浓度也增加;另一方面, Cl⁻、Na⁺扩散进入 AIN 陶瓷内部也增加了杂质缺陷浓 度。二者综合导致 AIN 陶瓷传热过程中声子-缺陷散 射截面增大,降低了 AIN 陶瓷基体内声子平均自由程,从而导致陶瓷基体热导率下降。
